KENT WEIRS
BOWSTON WEIR OPTIONS APPRAISAL AND DESIGN

FINAL REPORT

Prepared for
South Cumbria Rivers Trust

Prepared by
cbec eco-engineering UK Ltd
JBA Consulting

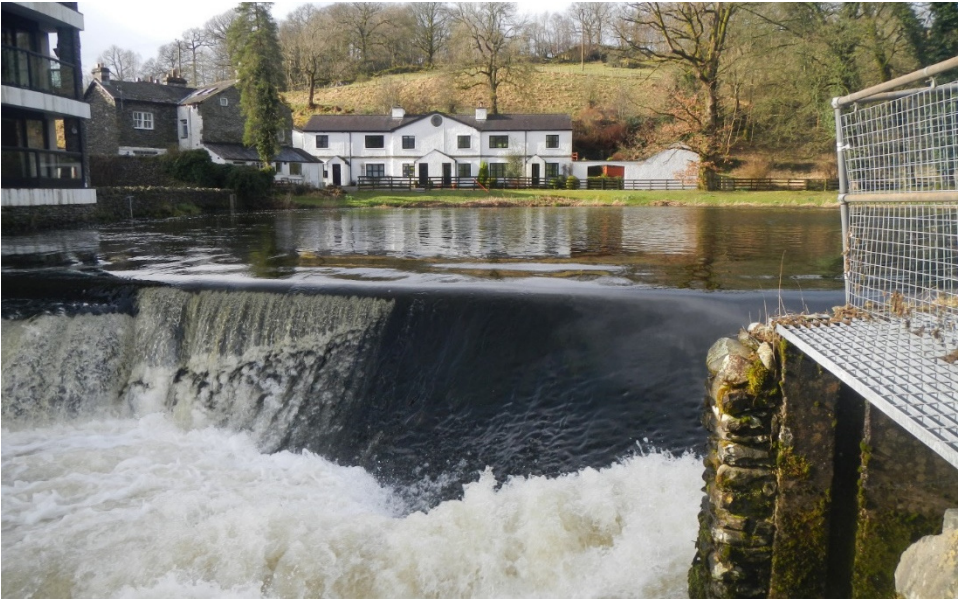
<p>Photo 1: Weir at upstream end of reach at Cowan Head</p>

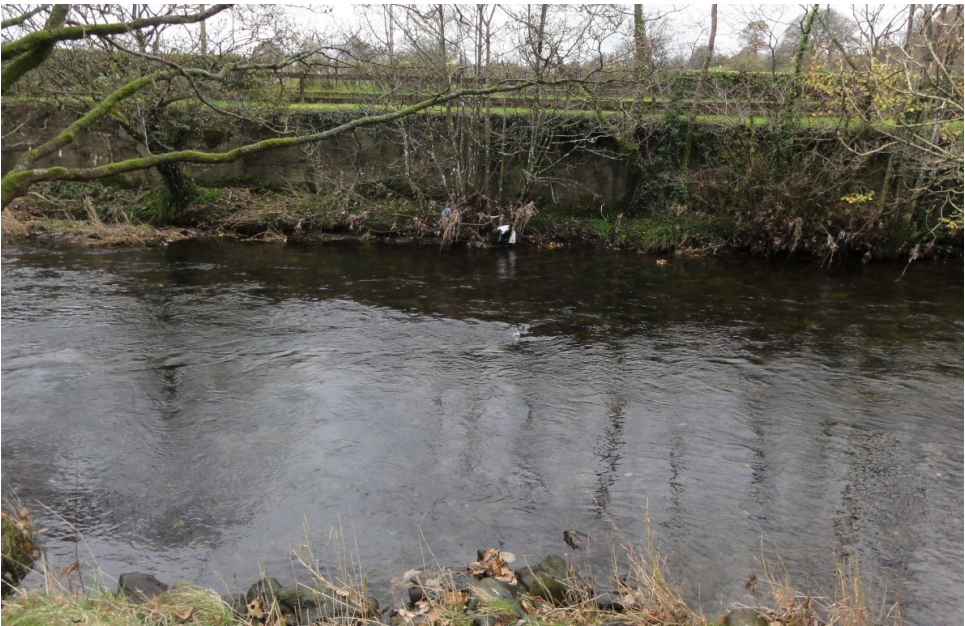
<p data-bbox="496 882 1390 916">Photo 3: Wall/ bank protection on right bank protecting access track/ road</p>

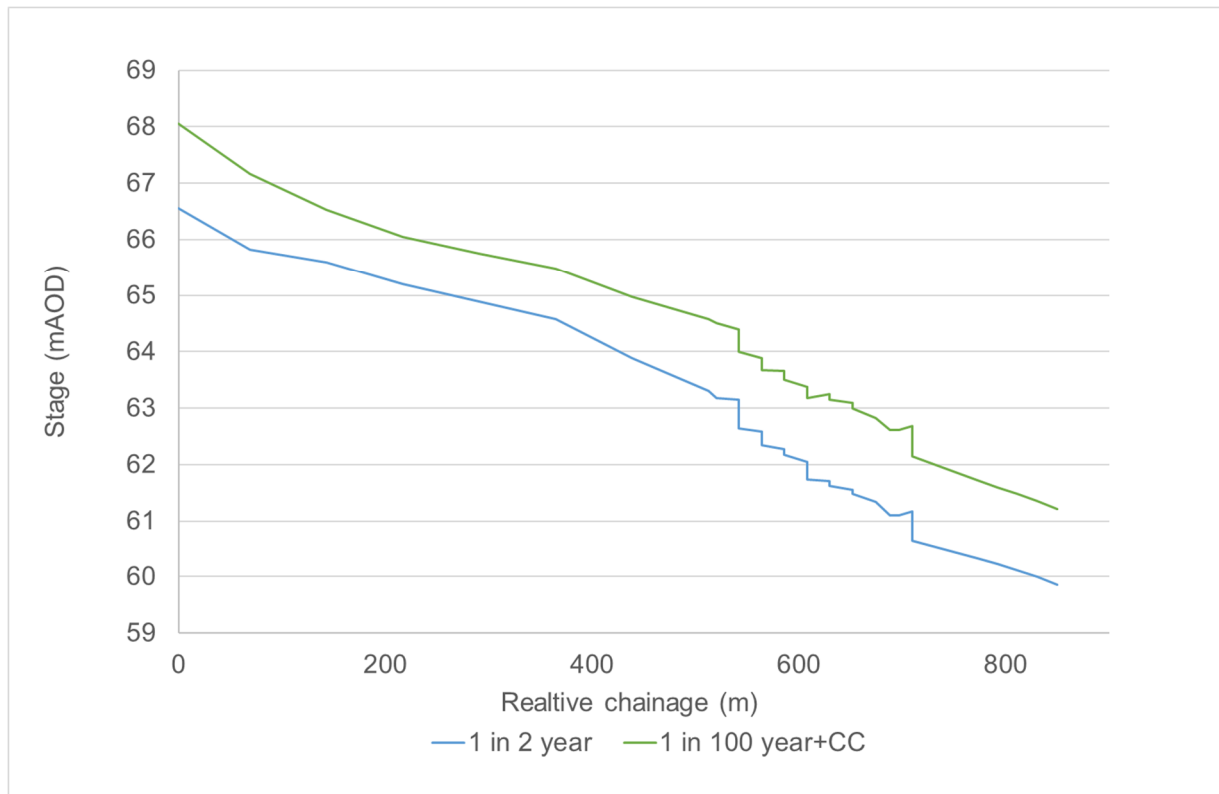
Figure 6.6 Long profile through Bowston design model (ISIS node KENT07_3013 to KENT07_2163) showing stage (mAOD) at the peak flow for each modelled event.

The most recent iteration of the design model has only been run for two return periods; the 2year and the 100year + climate change. Two long profile sections showing the stage (**Figure 6.3**) and velocity (

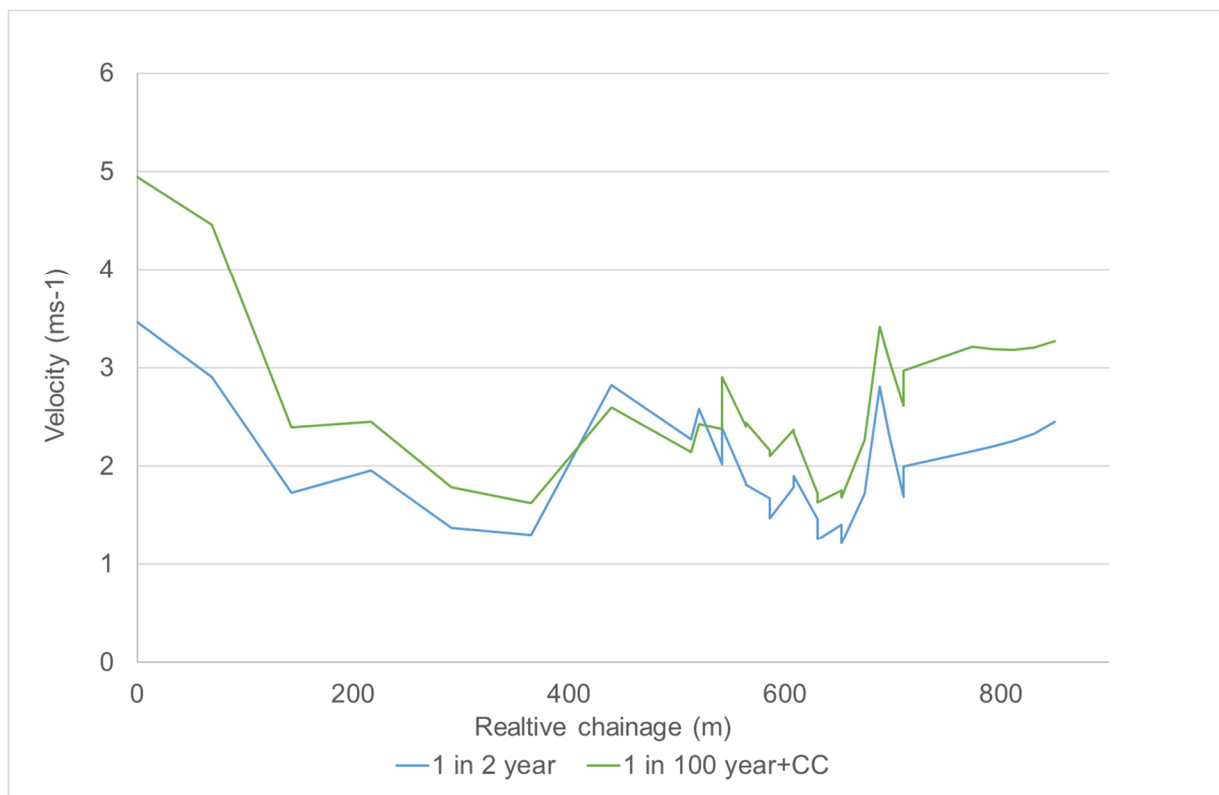
Figure 6.7 Long profile through Bowston design model (ISIS node KENT07_3013 to KENT07_2163) showing average modelled velocity at the peak flow for each modelled event.

Figure 6.4) at the peak flow for each return period have been provided. These long profiles extend from ISIS node KENT07_3013 to KENT07_2163, **Figure 6.1**. The relative chainage for each section from the model start is provided in **Table 6.2**.

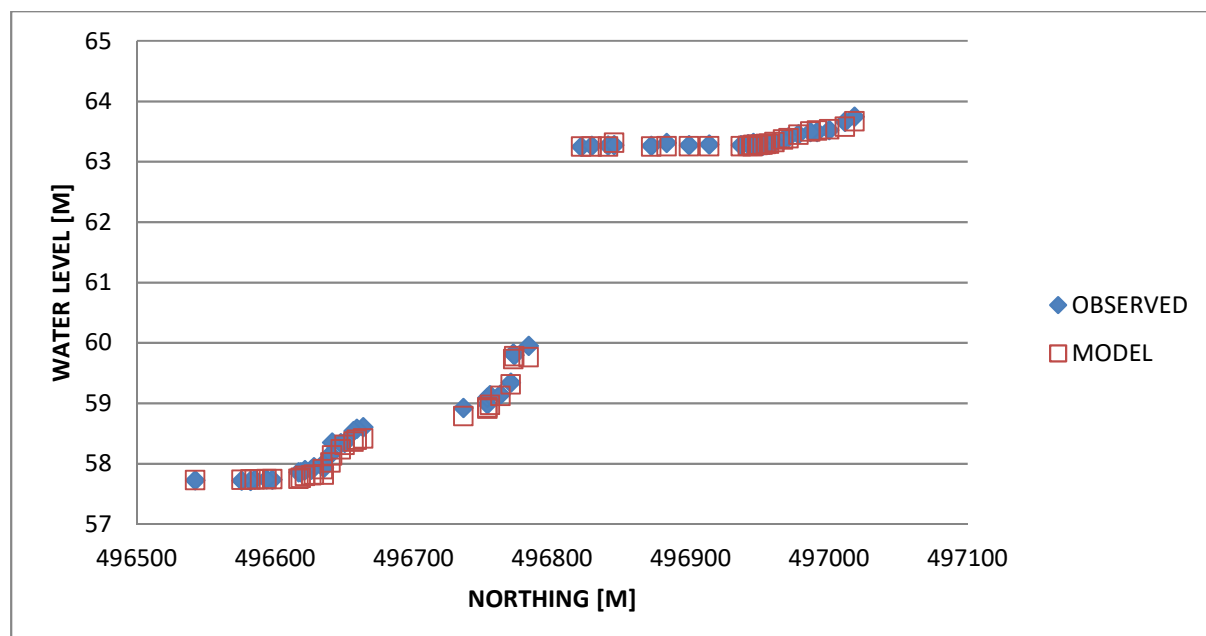
Figure 7.2 In channel calibration of 2D model. Existing conditions water levels.

The in-channel part of the 2D hydraulic model was calibrated using surveyed water levels at low flow. Baseline friction values were initially assigned using normal methods of site photographs, the UK CES roughness advisor and the Strickler equations, and adjusted for low flow values using Limerinos' method, with hydraulic radius and wetted area extracted from the hydraulic model, run with the gauged flow measured on the day of survey. Model results were compared to observed water levels and the baseline frictions adjusted slightly to suit. This method provides consistent frictions for low and high flows. Standard UK CES friction values were used for roughness zones on the floodplain, with a high value of 0.3 used for buildings, however, no buildings were inundated in any of the sediment transport model runs.

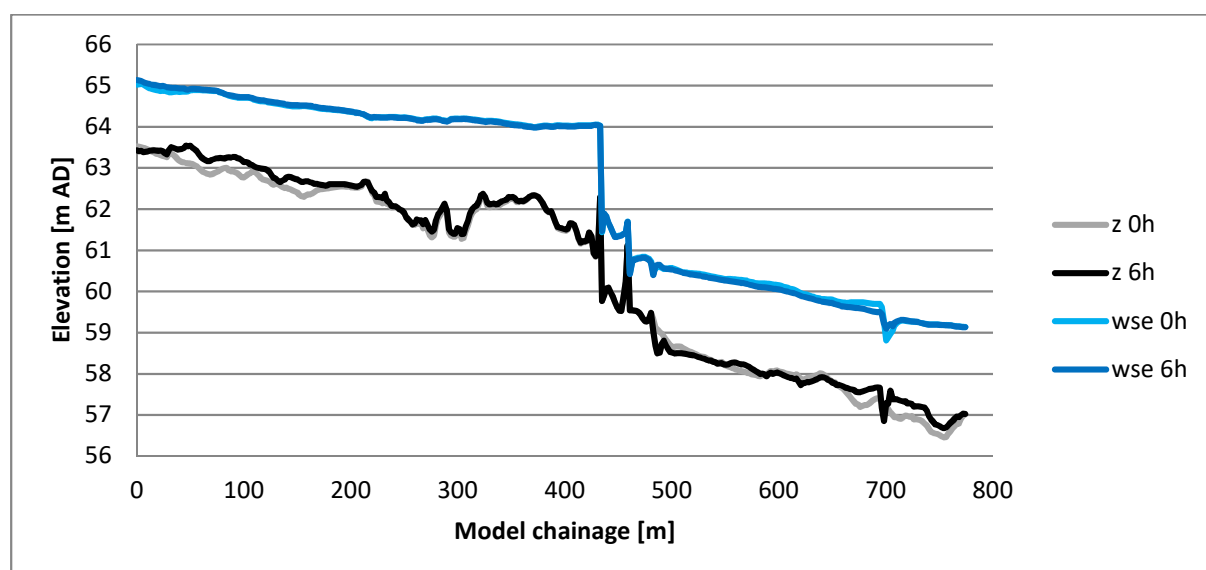
Figure 7.5 Long section of predicted erosion and deposition for the existing condition subject to a constant 1:2 year ‘channel forming’ flow (for 6 h).

Notable is the large amount of deposition in the upstream section. This deposition is likely to be an over estimate as a result of assumed capacity supply conditions. Of greatest concern is the predicted erosion through the bridge and deposition upstream and downstream of the bridge, potentially putting the bridge at risk. This conclusion is dependent, however, of the depth of mobile sediment at the bridge, and presence of a bedrock foundation.

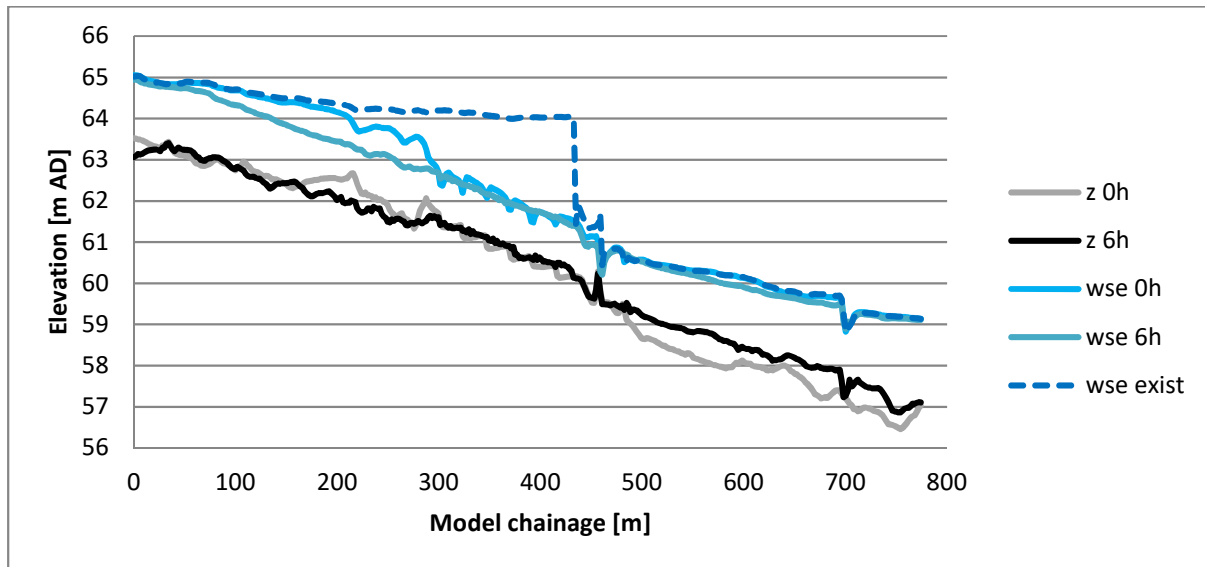
Figure 7.7 Long section of predicted erosion and deposition for the design condition subject to a constant 'channel-forming' 1:2 year peak flow (for 6 h). This model run is for zero sediment supply, but only differs from the capacity sediment supply in the first 200 m.

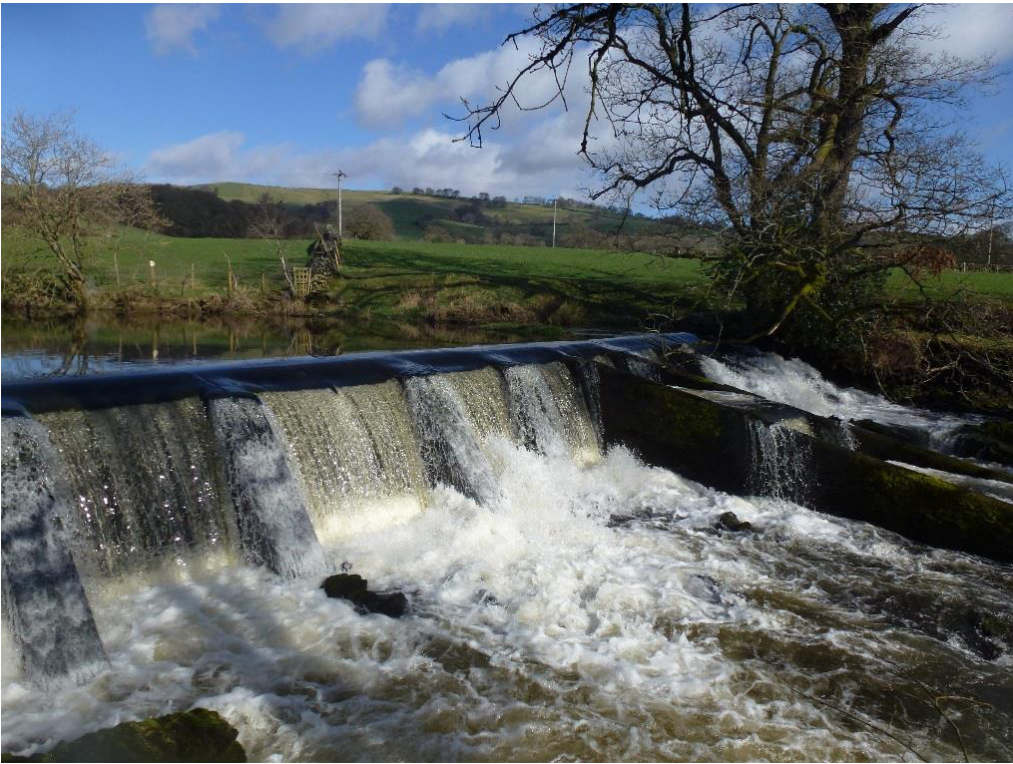
A photograph of Bowston Weir taken from the right bank looking downstream. The weir is a low, wide structure with water cascading over it, creating white rapids. The background shows a green field and a blue sky with some clouds. Bare trees are visible on the right bank.	<p data-bbox="1248 322 1426 477">Bowston Weir from Right bank (downstream)</p>
<p data-bbox="108 1158 129 1184">2</p>

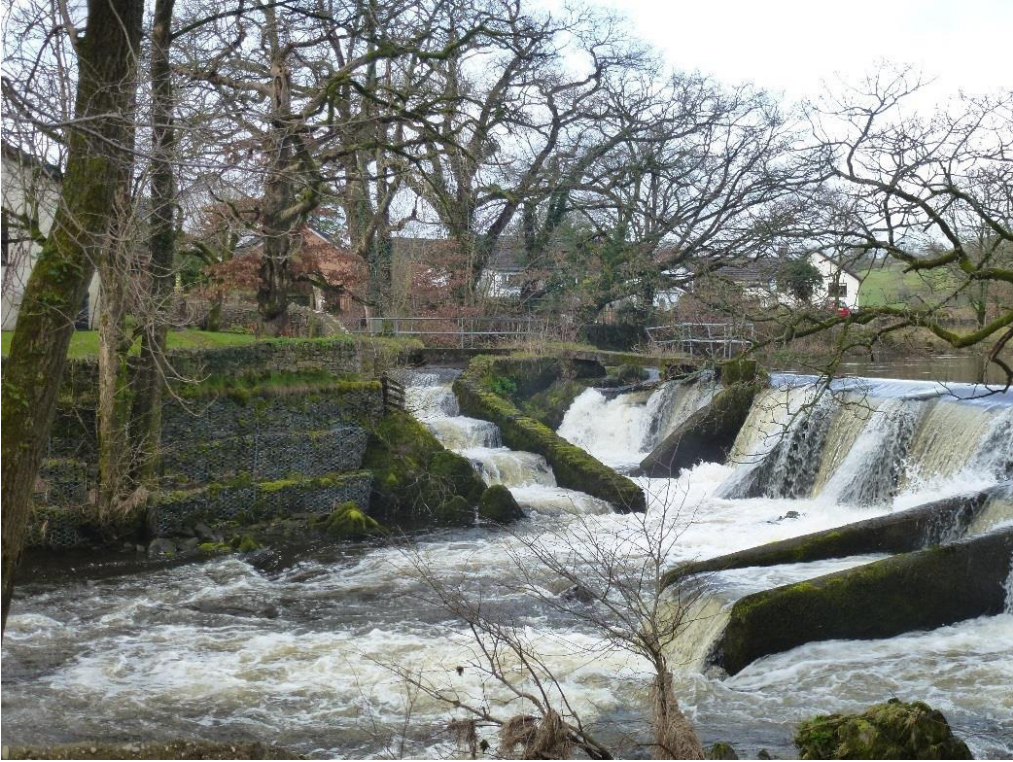
A photograph of Bowston Weir taken from the left bank looking downstream. The weir is a low, wide structure with water cascading over it, creating white rapids. The background shows a green field and a blue sky with some clouds. Bare trees are visible on the left bank.	<p data-bbox="1248 1158 1426 1285">Bowston Weir from left bank (downstream)</p>

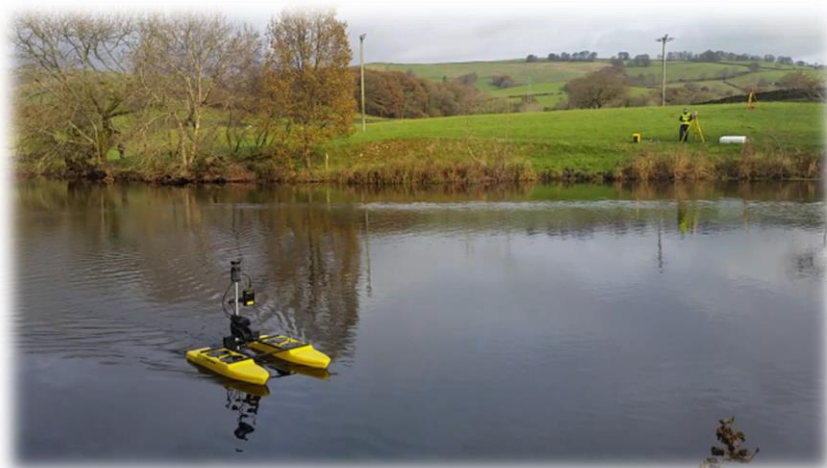
Figure C1. Hydrone RCV in action (left)

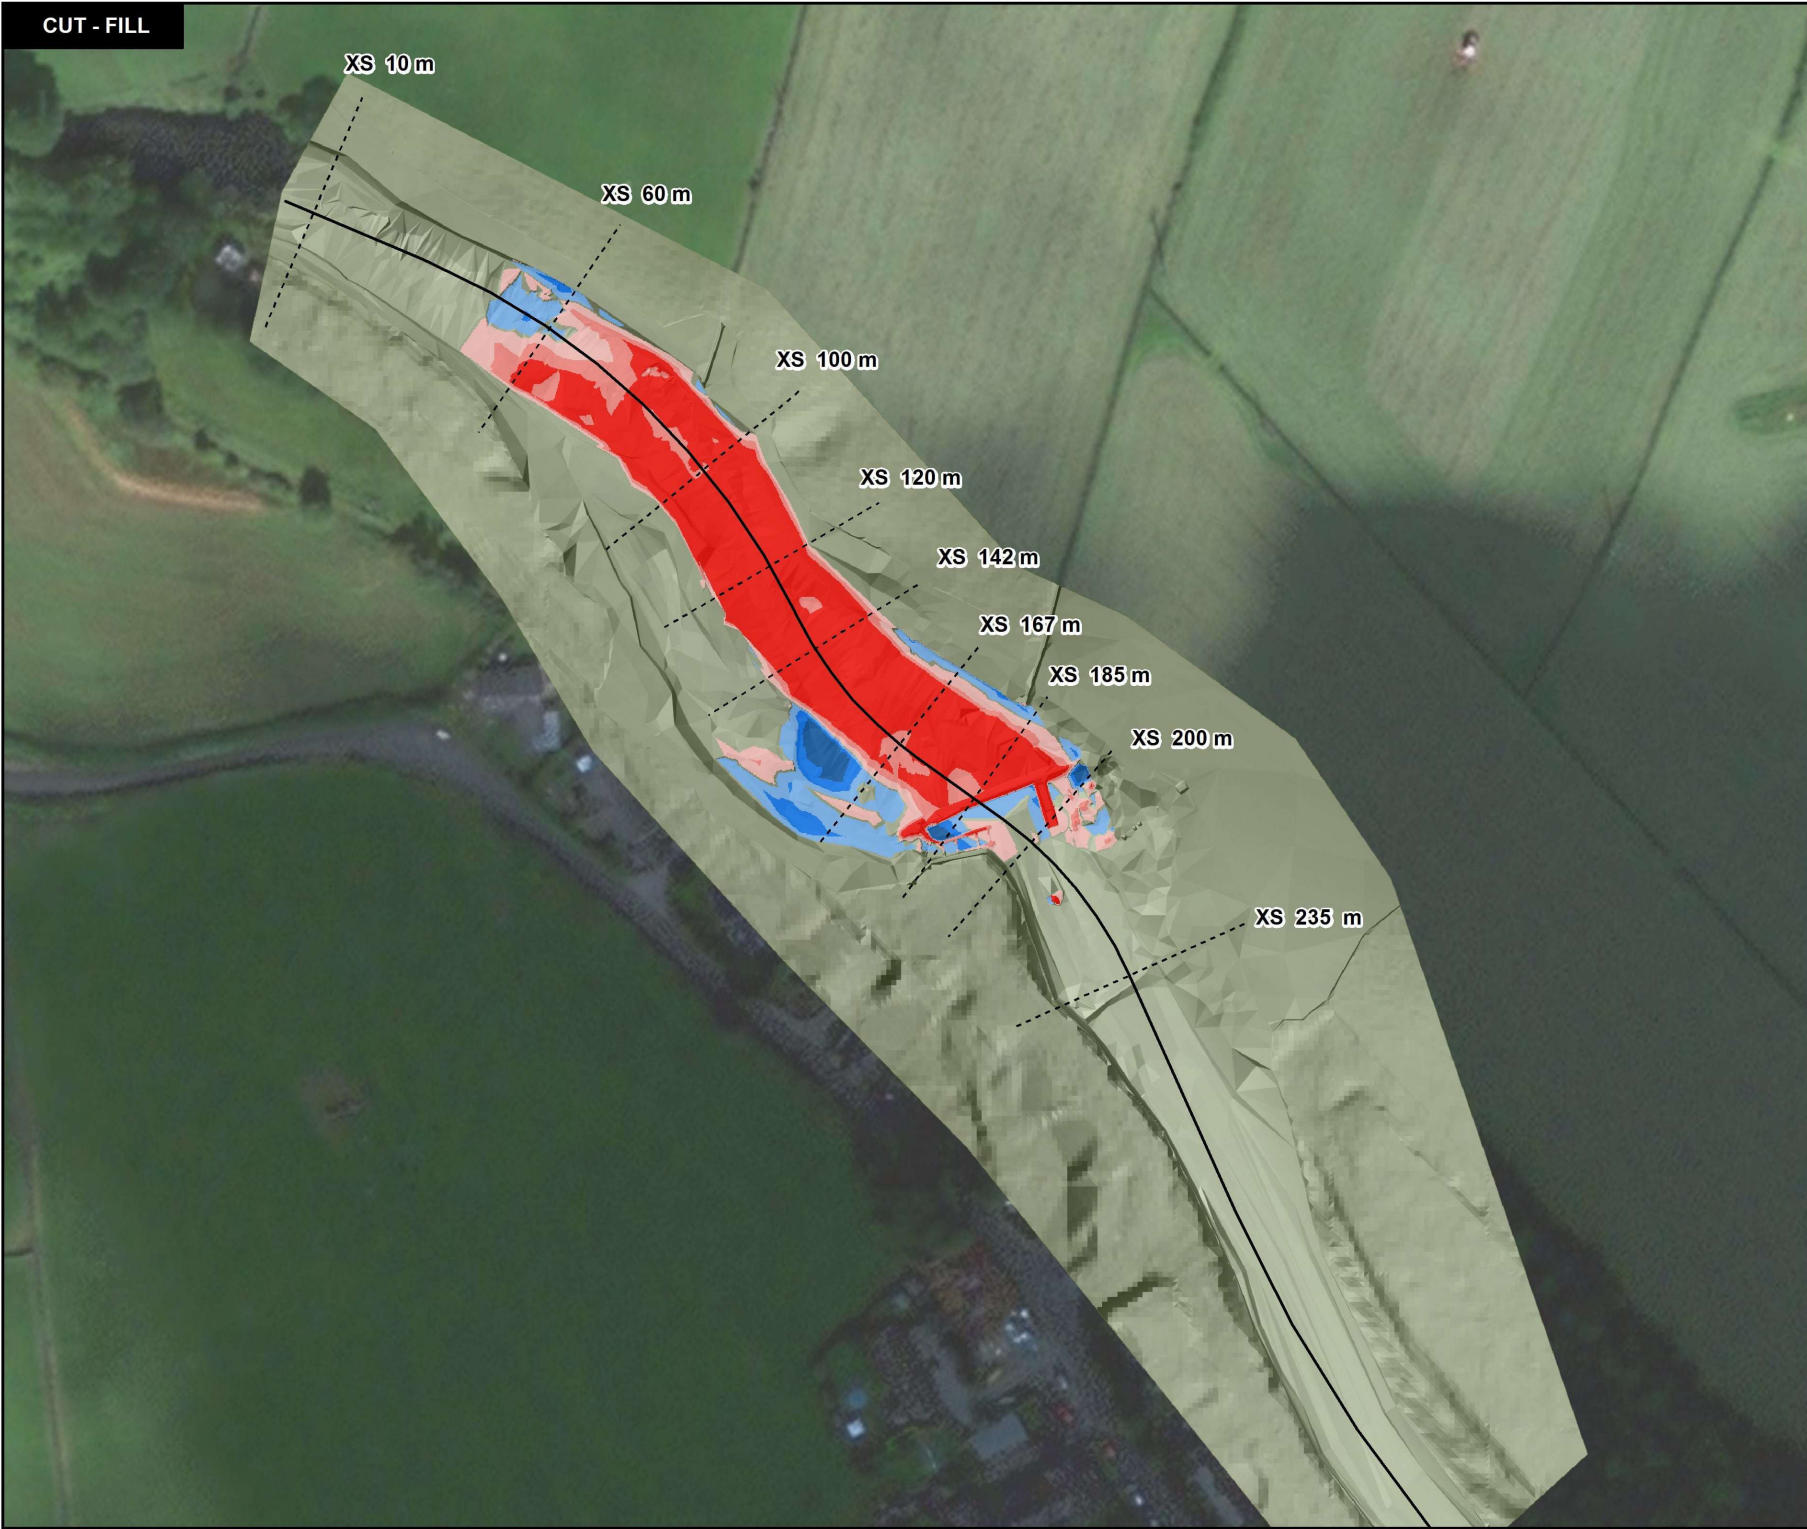
Project Number	UK17 - 1005		
Project Title	Kent weirs		
Drawing Title	BOWSTON WEIR - CUT / FILL		
Drawing Number	201802070002		
CUMBRIA (England)			
Legend			
DEM difference Existing - Design conditions			
<div><div>< - 1 m [CUT]</div><div>- 1 m - - 0.5 m [CUT]</div><div>- 0.5 m - 0 m [CUT]</div><div>No difference</div><div>0 m - 0.5 m [FILL]</div><div>0.5 m - 1 m [FILL]</div><div>> 1 m [FILL]</div></div>			
Volume calculations (m3) CUT: 4,141 m3 FILL: 336 m3 NET: 3,805 m3 [CUT]			
Client			
<div><div>02550</div><div>m</div></div> <div>Scale @ A4 - 1: 1,500 British National Grid / GCS OSGB 1936</div>			
Designed	Drawn	Reviewed	Approved
LC	Jl	AW	
Date	February 2018		
Hydrology Hydraulics Geomorphology Design Field Services			
Service Layer Credits: Contains OS data © Crown Copyright and database right 2017 Source: Esri, DigitalGlobe, GeoEye, Earthstar Geographics, CNES/Airbus DS, USDA, USGS, AeroGRID, IGN, and the GIS User Community
